Base Building in a High-Density Urban Area

New York City

By Marco Shmerykowsky, P.E.

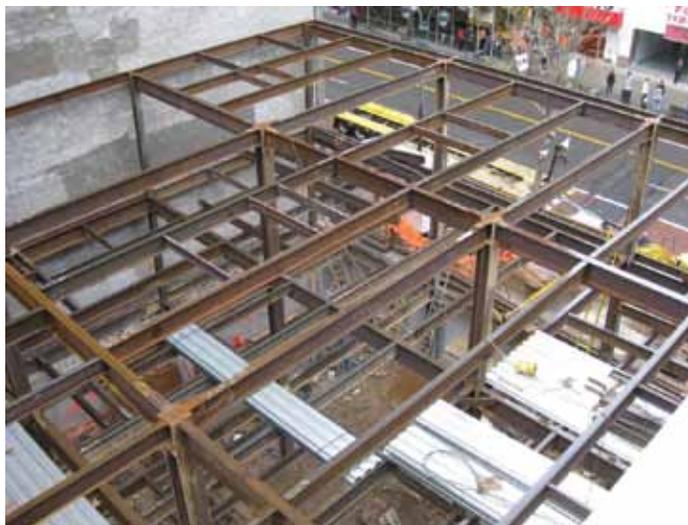
Figure 2: The structural frame as it neared completion.

Conceptually, it was a simple building: a structural frame of ASTM A992 Grade 50 steel columns spaced approximately 25 feet on center in both directions and a floor construction consisting of a 2½-inch thick normal weight concrete slab on a 3-inch composite metal deck spanning to composite steel beams (Figure 2). To preserve an all-important floor area for the eventual retail space, the structural engineers chose to use moment frames rather than braced frames as the lateral load resistance system. In this city, losing a few square feet of retail space could cost a client millions. In all, the three levels – a subsurface cellar plus the ground and second floors – totaled 24,000 square feet.

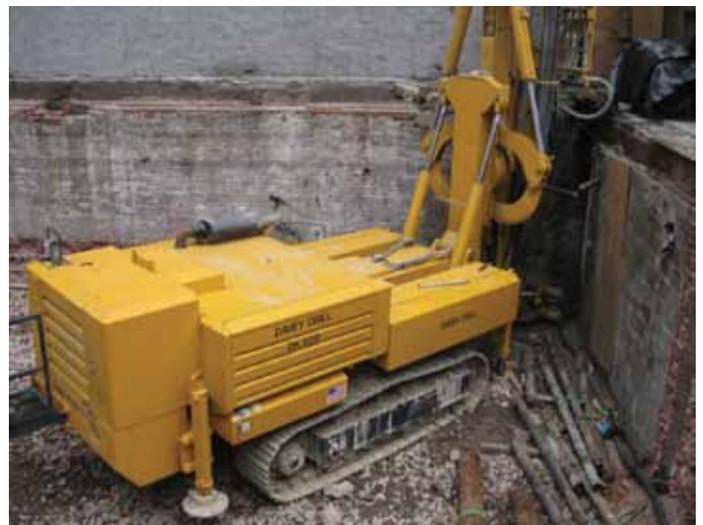
Figure 3: The micro-pile rig. The width of the rig limited how close its drill mechanism could get to the face of the building.

Like the initially proposed spread footing system, the pile system also had to be designed for column-footing eccentricities. The width of the micro-pile rig brought in to drill holes for the mini-caissons limited how close its drill mechanism could get to the face of the building (Figure 3). As a result, the pile groups had to be pulled back from the column line and strap beams had to be installed to handle the pile caps' overturning moments.

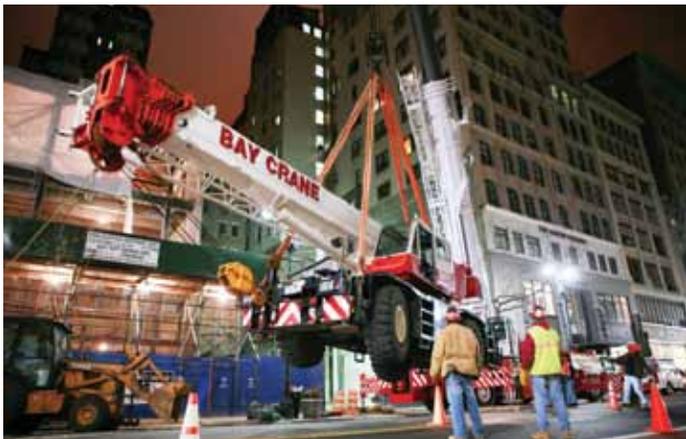
Figure 4: The primary construction crane was lifted from the street level and into the excavated site during the Department of Transportation's sanctioned off-hours.

And here was the rub: that crane would erect the building's two story steel frame. The construction team responded with typical creativity. It was a surreal image: a massive construction crane lowering another crane, half its size but otherwise identical, into the excavated site (Figure 4). From the excavated site, this crane erected the bulk of the building's structural steel frame. From within the pit, the crane lifted the columns into place. Beams were similarly lifted into place by the crane and then secured by workers (Figure 5). Because of the confining nature of the site, the final structural bay was erected only after the crane was lifted off the site. Erection for the final structural bay proceeded during the Department of Transportation's sanctioned off-hours, during which time the crane could operate from the street level.

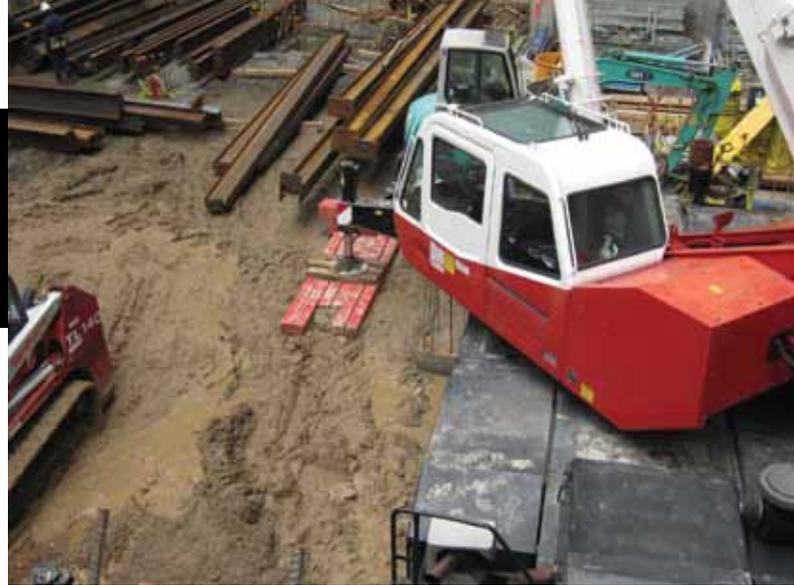
Figure 5: The primary construction crane before the erection of the structural frame. Here, it is positioned in the southeast corner of the site.
